ShoreZone Summary Report

Burrard Inlet

ShoreZone Habitat Mapping Summary Report

Burrard Inlet Survey Area

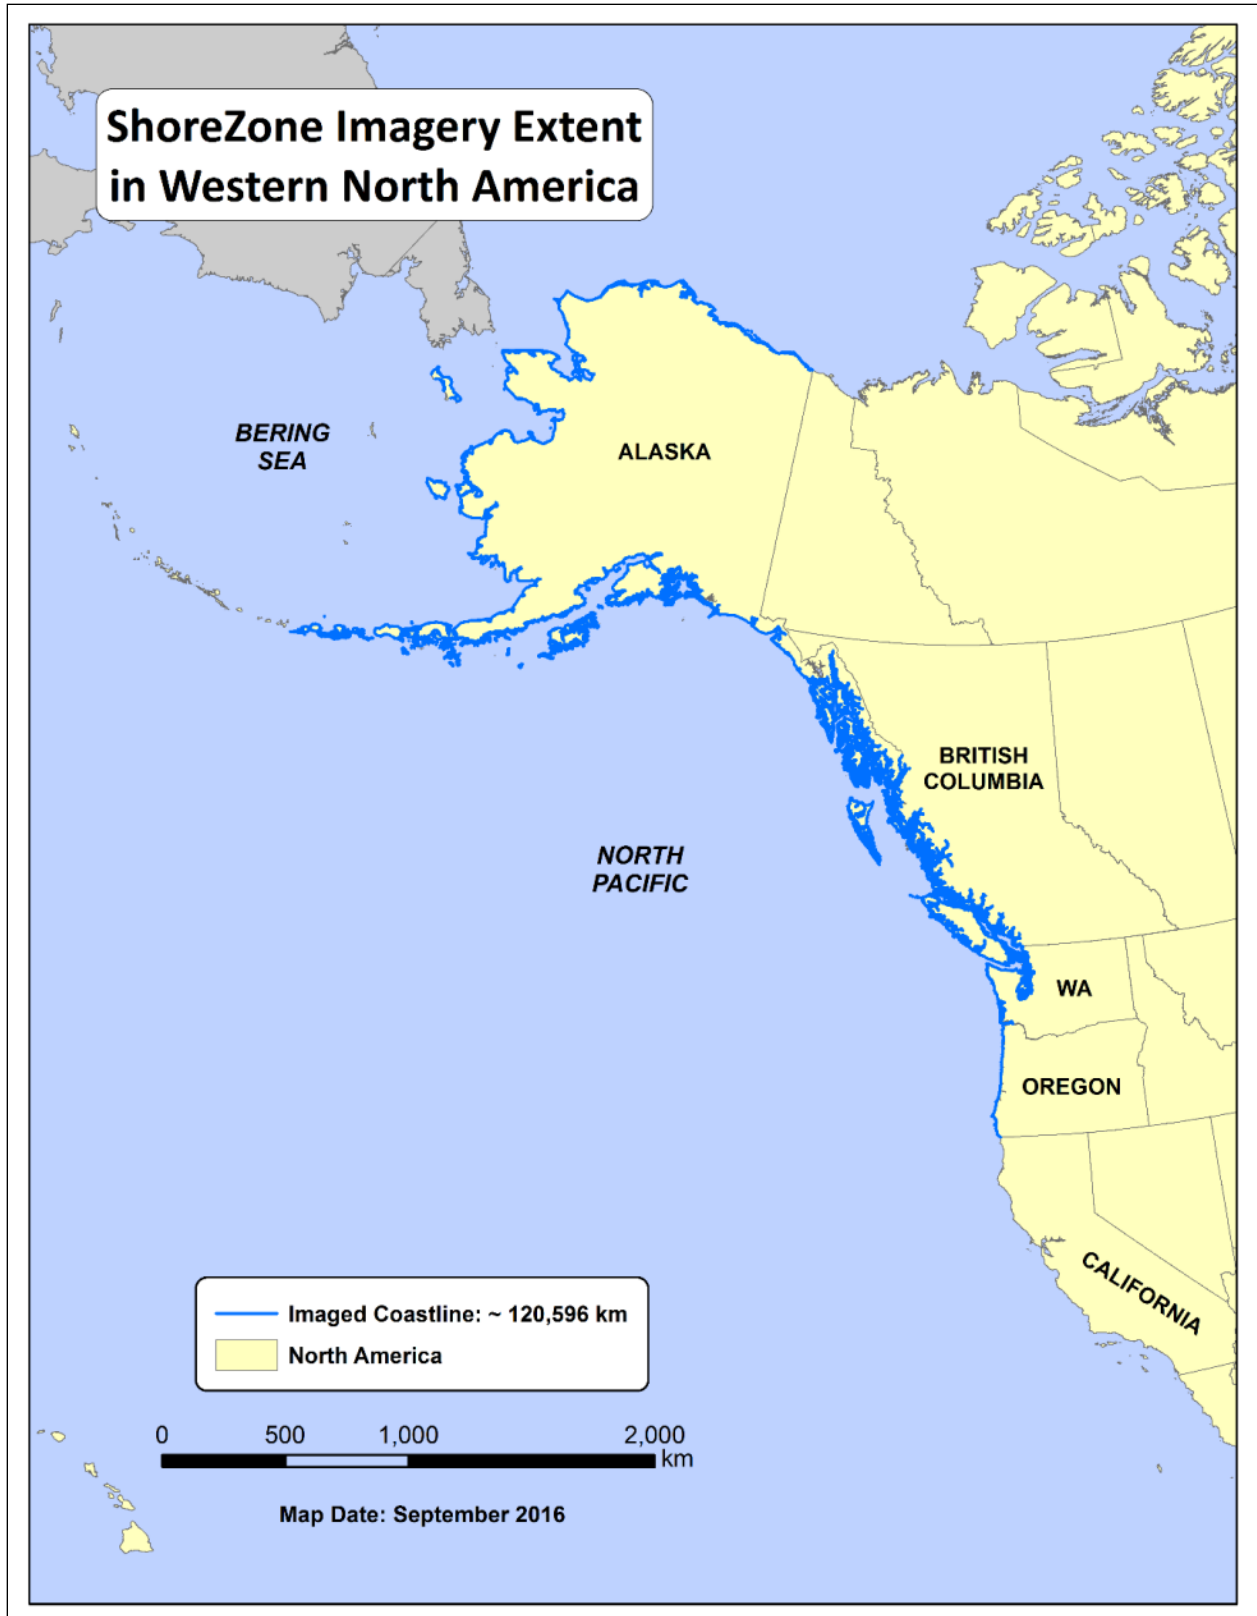
Figure 1. Extent of ShoreZone imagery in Alaska, British Columbia, Washington State and Oregon as of April 2018. Some sections of the coastline in BC have been imaged more than once.

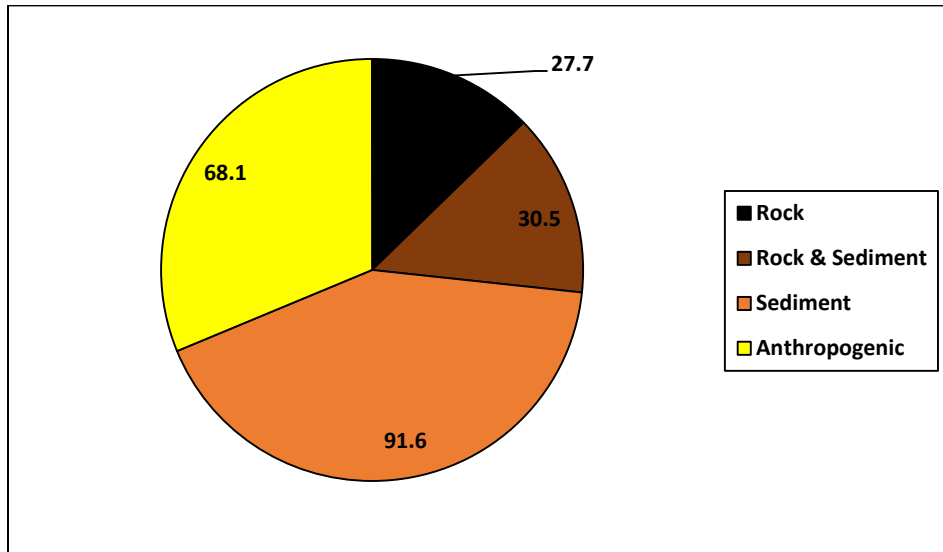
Figure 4. Grouped Coastal Class categories by shoreline length (km).

The Coastal Class is used to define along-shore coastal units based on the dominant process, geomorphic features and other attributes such as substrate size, across-shore width, and slope (Cook *et al.*, 2017 after Howes *et al* 1994). The principal characteristics of each along-shore unit are used to assign one of 39 overall unit classifications. Sediment shorelines (42.0%) and Anthropogenic shorelines (31.3%) dominated the Burrard Inlet area. Rock and Sediment shorelines followed with 14.0% and Rock shorelines were found along 12.7% of the coast (see Figures 3 and 4 for distribution and summary statistics). The description for each Coastal Class category in the survey area is given in Table 1. Photographic examples of the major Coastal Classes mapped in Burrard Inlet are found in Appendix A, Table A-1.

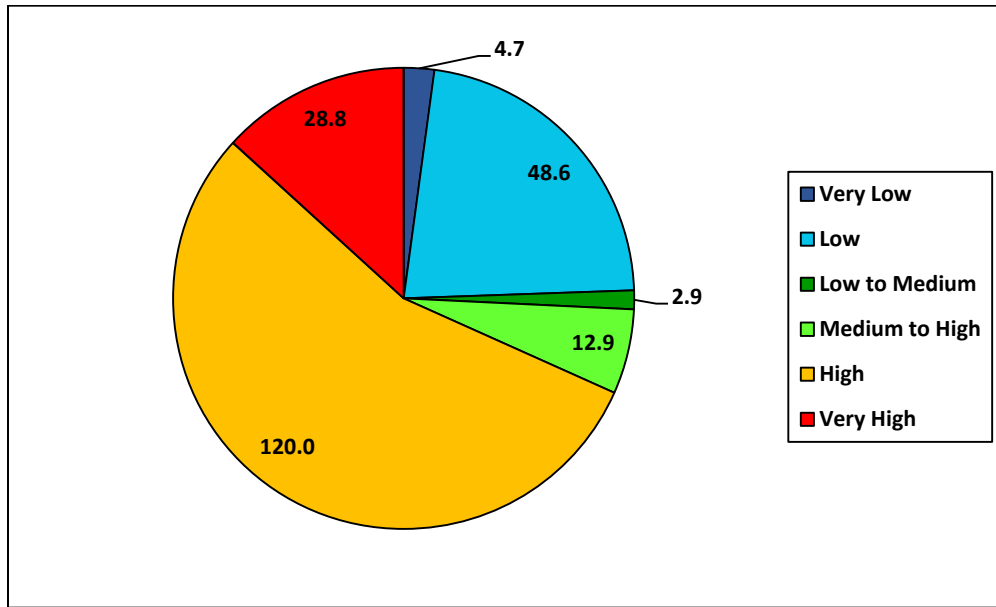
Figure 6. Grouped most sensitive ESI categories by shoreline length (km).

Burrard Inlet is dominated by the grouped High and Very High categories (68.3% of shoreline length). These sections of the shoreline have a potentially high sensitivity to oil. At the other end of the spectrum, only 24.4% of the shoreline was mapped with a potentially low sensitivity to oil (Figures 5 and 6). The summary of Shore Type by ESI class can be seen in Table 2.

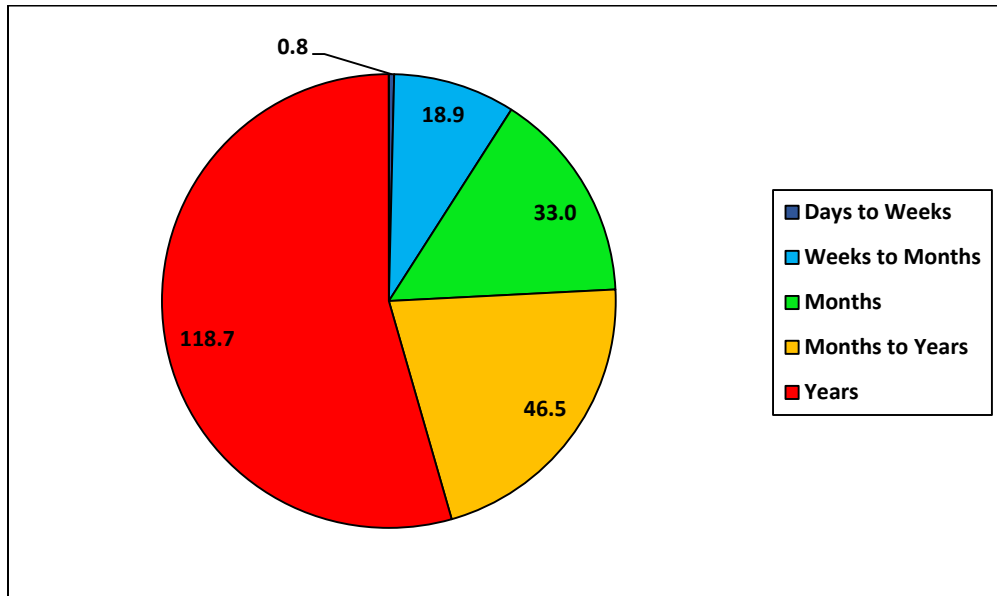
Figure 8. Oil Residence Index (ORI) categories by shoreline length (km).

The Oil Residence Index (ORI) is a rating between 1 and 5 with a value of 1 indicating a relatively short oil residence (days to weeks) while a value of 5 reflects potentially very long oil residence times (years). An ORI value is applied to each alongshore unit and to each across-shore component based on sediment texture and wave exposure (Cook *et al.* 2017). The ShoreZone ORI was developed by Dr. John Harper based on his many years of experience with cleaning up oiled shorelines, starting with the Exxon Valdez spill in Prince William Sound in Alaska. Lower wave exposures and unconsolidated sand and gravel sediments lead to high ORI values for 75.8% of the shore segments in Burrard Inlet, indicating oil residence times are on the order of months to years (see Figures 7 and 8 for distribution and summary statistics).

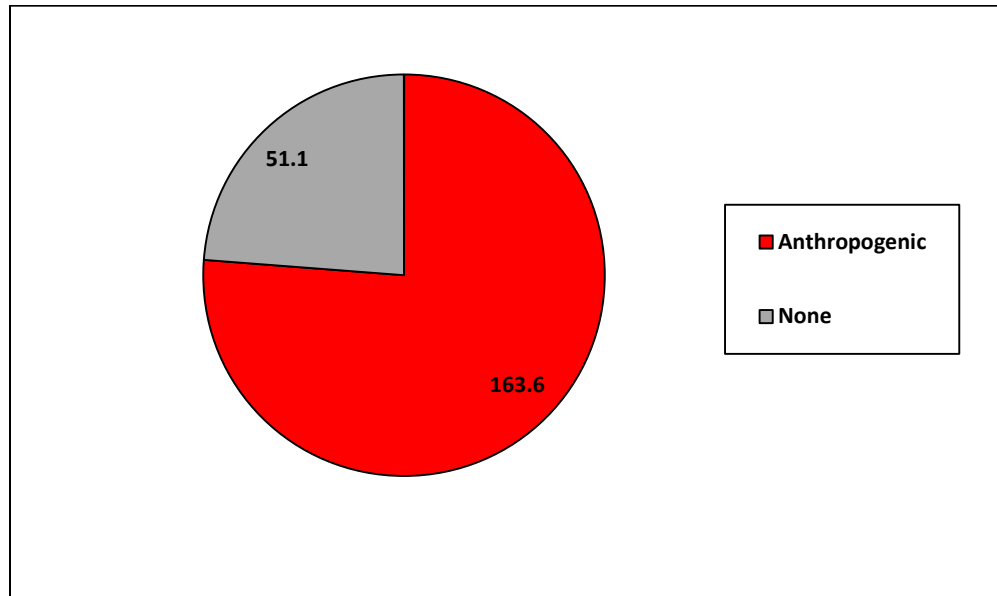
Figure 10. Coastal Vulnerability Observation categories by shoreline length (km).

The Coastal Vulnerability Module of ShoreZone includes several attributes to provide qualitative estimates of the vulnerability of a unit to impact from sea level rise, whether that is due to anthropogenic causes or natural phenomena such as storm surge (Cook *et al.* 2017). One of these attributes are observations of features important for estimating the potential impact of coastal inundation based on the condition of the shoreline in the supratidal. Natural shorelines are, generally, considered to be more resilient to inundation due to features such as marshes or dunes while shoreline hardening or modification can cause the shore to lose resiliency. These observations are meant to complement the ‘Anthropogenic’ Coastal Class (Page 7) which indicates significant modification of the intertidal and the Shoreline Modifications attribute (Page 14) which catalogues the type of modifications observed (supratidal or intertidal). In the Burrard Inlet survey area 75% of the shoreline has some form of Anthropogenic modification in the supratidal or backshore (see Figures 9 and 10 for distribution and summary statistics). It is important to point out that these areas are not necessarily areas of vulnerability, but areas that could have reduced resilience.

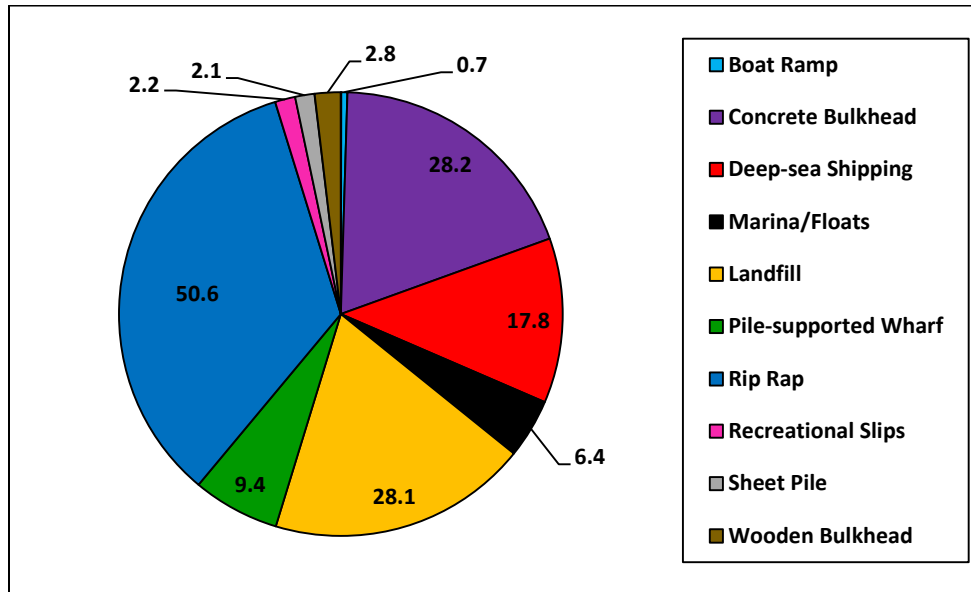
Figure 12. Shore Modifications by estimated shoreline length (km) of each modification type.

The Shoreline Modification attribute provides a thorough catalogue of the specific types of anthropogenic modification in each unit (Cook *et al.*, 2017). This includes many modifications within a given unit. For example, if both riprap and a pile-supported wharf occur, both are catalogued in the appropriate zone of that unit with an estimate of the alongshore length of the unit that modification covers. A total of 68.9% of the shoreline (taking the estimated length of that modification within the unit into account) exhibits shore modifications in the Burrard Inlet study area (Figure 12). Rip Rap was the most commonly recorded observation (34.1%) with Concrete Bulkheads along 19.0% of the shore and Landfill along 18.9%. The associated map (Figure 11) shows the distribution of primary shore modifications though it should be noted that any given modification is necessarily along the entire length of the indicated shore unit. The Geodatabase delivered with this report displays each shore modification with a specific length category (meters) along the shoreline pertaining to each unit as well as the specific zone (supratidal or intertidal) the modification occurs in.

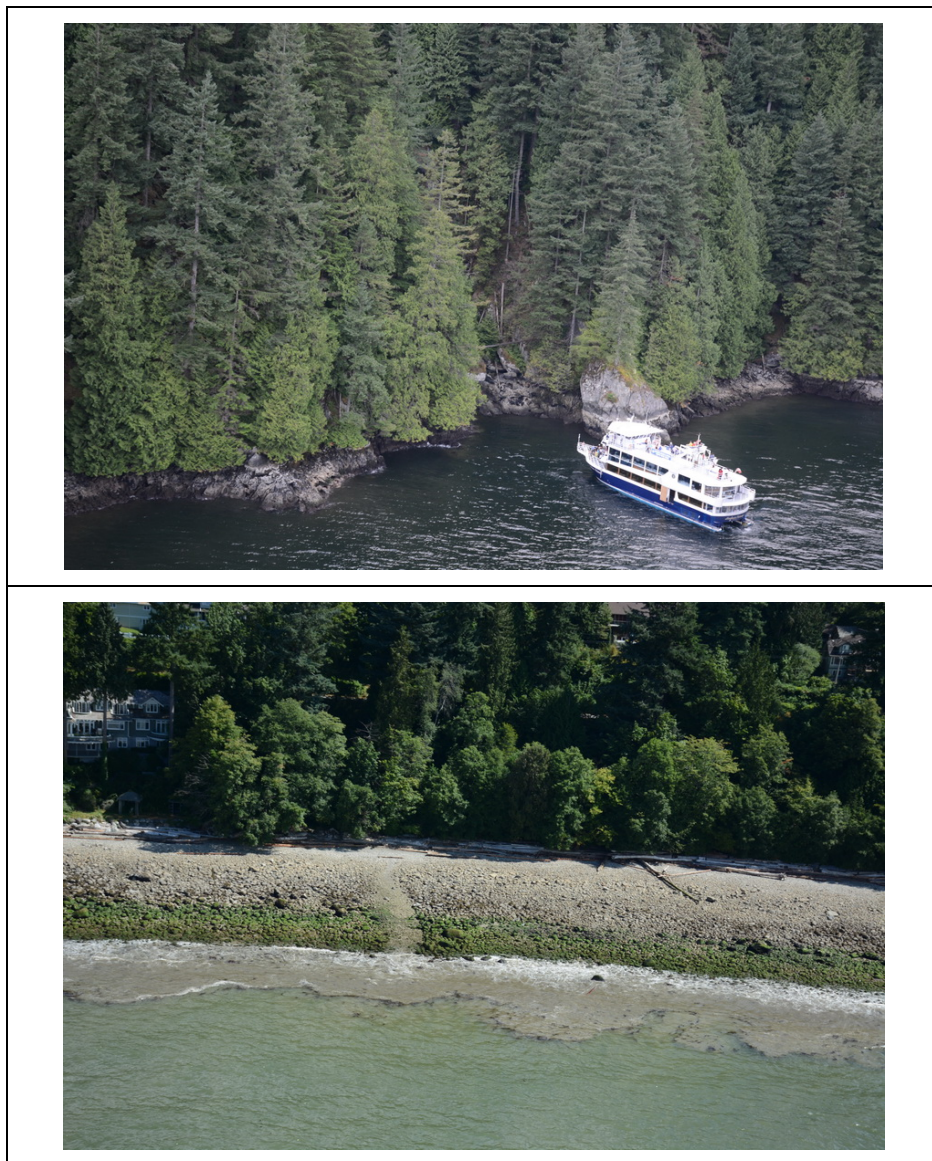
Figure 13. Examples of the Riparian Overhang attribute on a narrow rocky shore in Indian Arm (bc17_br_02175) (top) and on a sediment beach in outer Burrard Inlet (bc17_br_00106) (bottom).

This attribute was classified at the request of the client for this project. The Riparian Overhang records the percent alongshore length category of the unit that has trees overhanging the intertidal zone. It does not include areas where trees are only overhanging the supratidal. Riparian overhang of the intertidal provides shade to the beach and can influence the suitability of the habitat for beach spawning forage fish. Many units recorded with riparian overhang in this survey area are in the rocky, fjord area up Indian Arm and therefore not likely to be suitable for forage fish so this attribute may need to be combined with Coastal Class or the across shore materials to determine the impact of shade on forage fish habitat. Photos of two examples of riparian overhang are found in Figure 13 and a map of the distribution of this attribute is found in Figure 14.

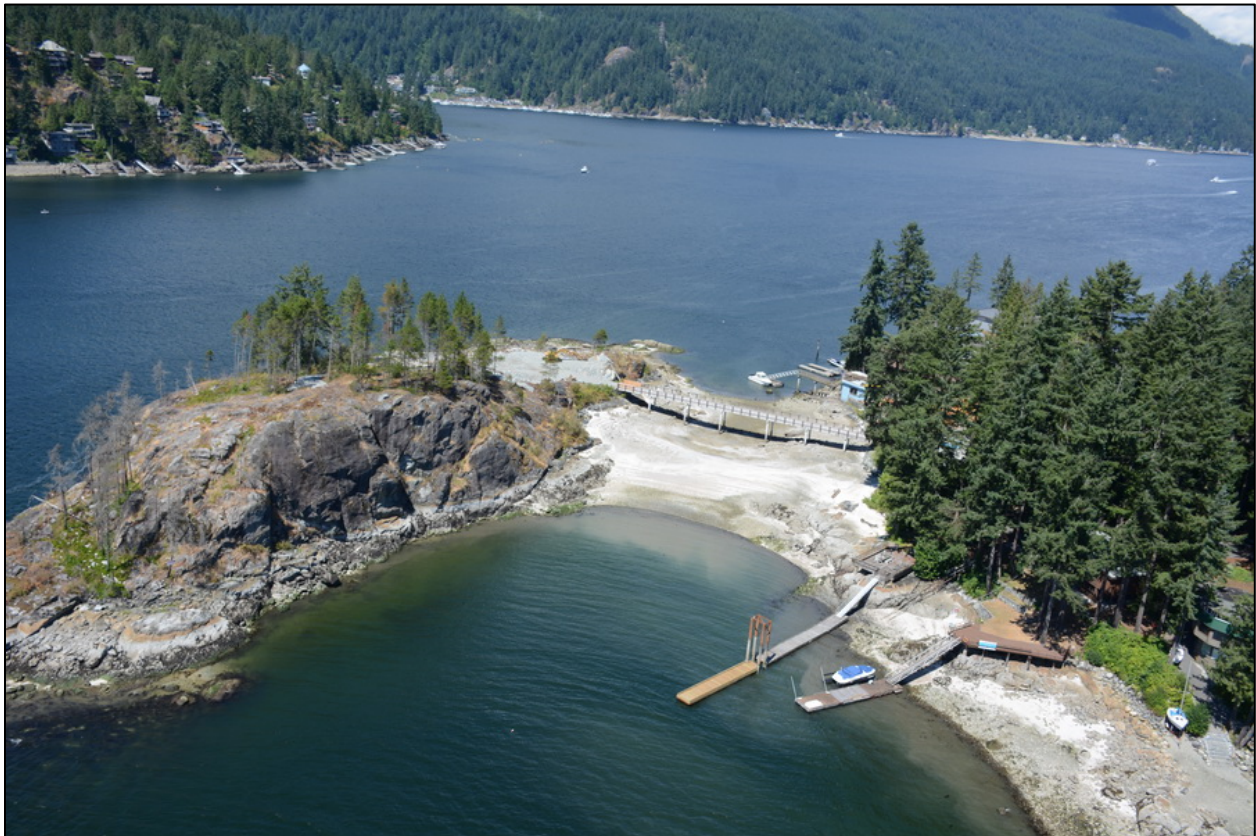
Figure 16. Example of murky subtidal conditions during the ShoreZone imaging survey in July 2017. The 2015 Burrard Inlet-Indian Arm Eelgrass Mapping report indicated there was a patchy subtidal eelgrass bed off the tombolo between the mainland and this island. The shallow subtidal is not visible in this image so we were not able to capture that bed in the ShoreZone mapping.

Eelgrass was recorded in the intertidal in 2.7% of units and in the subtidal in 2.8% of units so it was not common in the survey area. Eelgrass was noted at Spanish Banks, mixed with foliose green algae, although it had not previously been recorded as an area with eelgrass habitat. It is possible that area has been colonized by *Zostera japonica*, an introduced eelgrass that occurs higher in the intertidal than the native *Z. marina*. We cannot distinguish between the species in an aerial survey. We intend to check this observation as part of the ground survey planned for the area in summer 2018. If needed, the database will be updated to record what is discovered. We also compared the distribution of Eelgrass as mapped with ShoreZone with the 2015 Burrard Inlet-Indian Arm Eelgrass Mapping report (Rao 2015). ShoreZone captured the larger beds but missed some of the small, patchy subtidal beds in Indian Arm. Upon review of the imagery it was determined those beds were not visible on the day the imagery was taken due to the murky conditions immediately off the beach (see Figure 16 for an example). See Figure 17 for a map of the distribution of Eelgrass in the survey area from the ShoreZone observations.

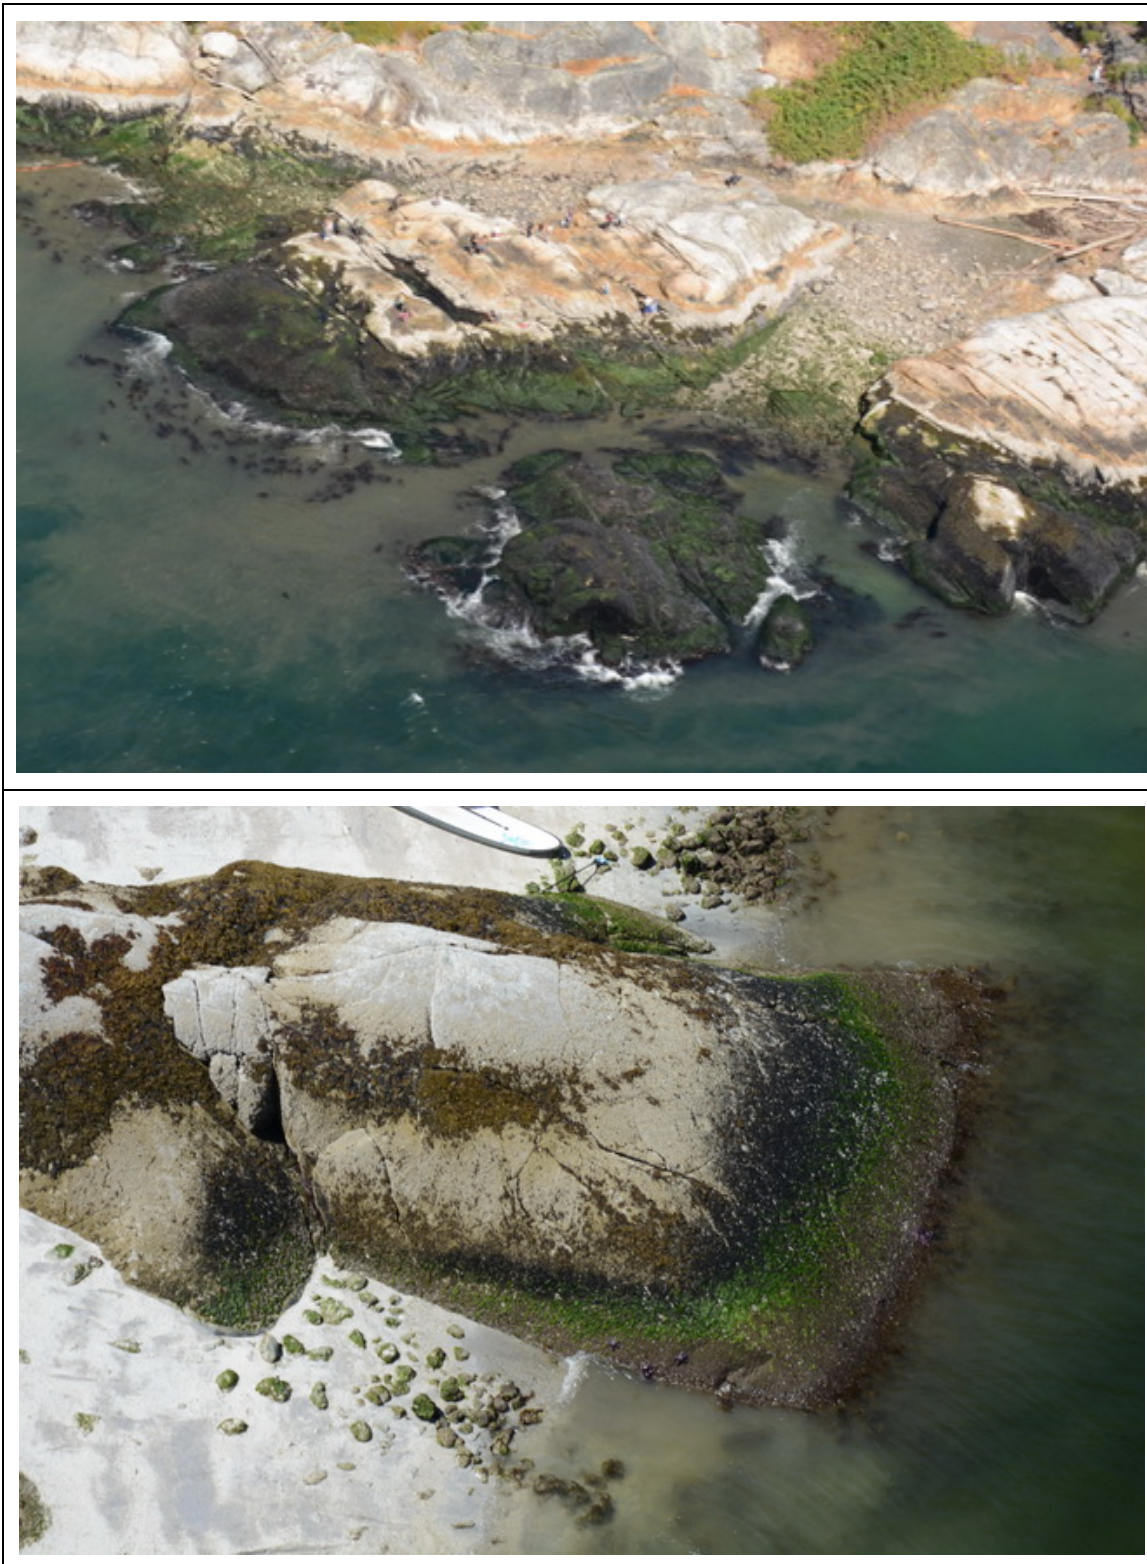
Figure 19. Examples of the Blue Mussel bioband at Point Atkinson (bc17_br_00007) (top) and at the entrance to Indian Arm, near Deep Cove (bc17_br_01945) (bottom). Purple Ochre Stars are visible at the waterline in the lower photo. Both photos have been cropped for better illustrative purposes.

The Blue Mussel bioband was noted in roughly half the units (45.6% overall) and formed extensive beds on the rock substrate around Point Atkinson and on the beaches on the north shore of Burrard Inlet, to the west of the Lions Gate Bridge. It was also common on the cliffs in the Indian Arm fjord area. See Figure 18 for a map of the distribution of Blue Mussels in the survey area. It was interesting to note that the mussel beds in Burrard Inlet were more sprawling and did not appear to have a clearly defined lower limit in the intertidal, although some of the mussel beds noted further up the inlet appeared to be more well-defined. The lower limit of mussels is usually defined by predation by sea stars, which have recently been decimated by sea star wasting disease. It should be noted that Ochre Sea Stars (*Pisaster ochraceous*) could clearly be seen at the waterline in a few of the units in the more protected part of the survey area (Indian Arm) where the lower limit of the blue mussel bed appeared to be higher in the intertidal and have a more distinct lower limit. See Figure 19 for two photos showing examples of the diversity in the Blue Mussel band. We hope to explore these observations in the ground survey planned for summer 2018.

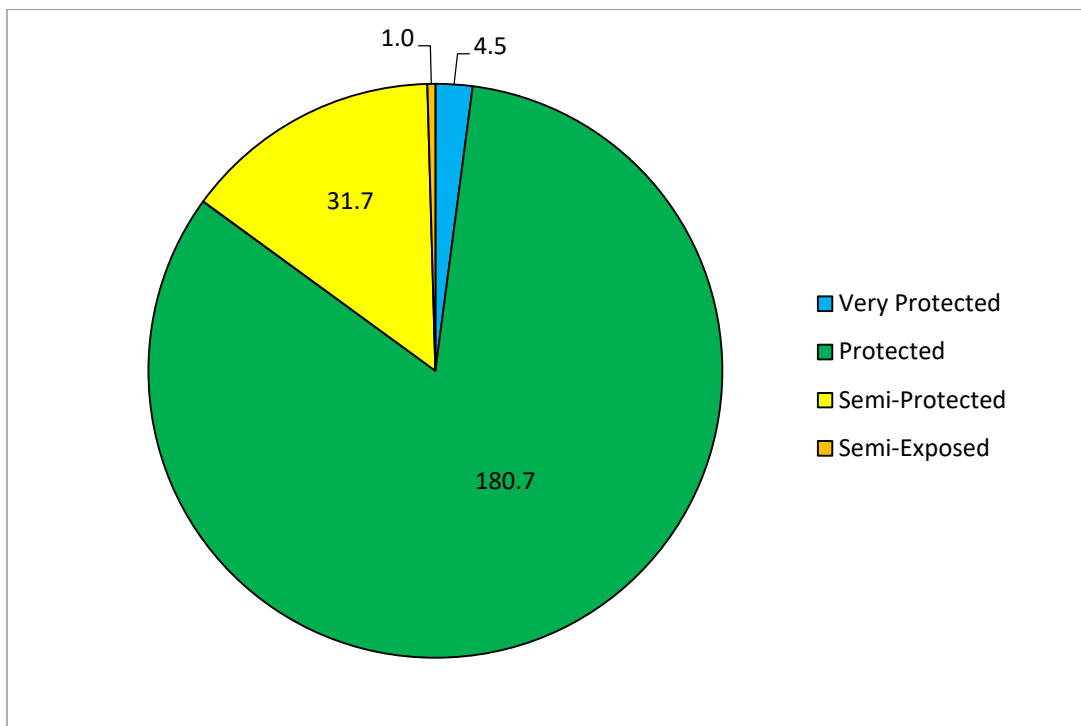
Figure 20. Distribution of biological wave exposures mapped in the Burrard Inlet survey area by shoreline length (km).

The distribution of the wave exposure categories mapped in the Burrard Inlet survey area are summarized in Figure 20 and a distribution map of the categories is shown in Figure 21. 99% of the coastline was in the lower exposure categories of Semi-Protected, Protected or Very Protected so this area is characterized by limited wave fetch.

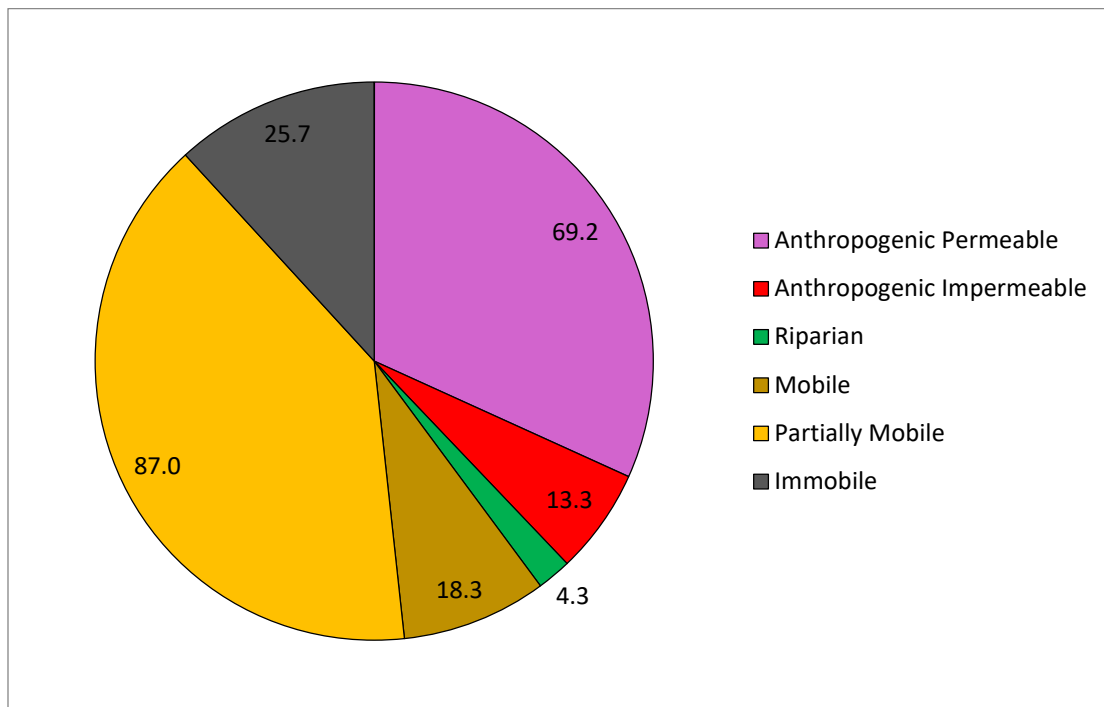
Figure 22. Distribution of Habitat Class categories in the Burrard Inlet survey area by shoreline length (km).

The distribution of habitat class categories mapped for the Burrard Inlet survey area are summarized in Figures 22 and 23. Partially Mobile and Immobile substrate classes are the dominant shoreline types (51.7%) with Anthropogenic habitat classes only somewhat less common (37.7%). These anthropogenic habitat classes included both areas with anthropogenic structures and areas where the natural sediment in the supratidal or intertidal had been significantly moved or altered, thereby affecting the biota present or the distribution of the biota in the unit. The Riparian, or Estuary, Habitat Class was quite rare (4.3% of the shoreline length) and is characterized by a significant source of fresh water flowing into the unit, the presence of a delta fan and the presence of marsh habitat (the Salt Marsh bioband).

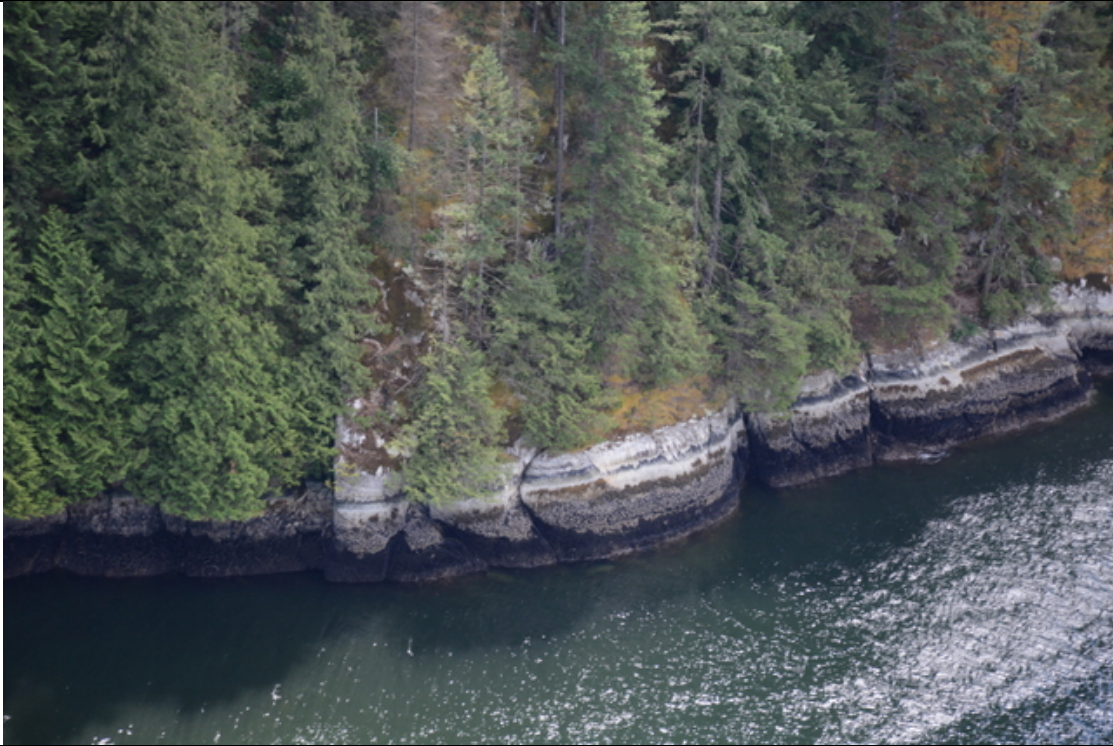
Photo bc17_br_02783: Example of Coastal Class 3; Rock Cliff.
Indian Arm.

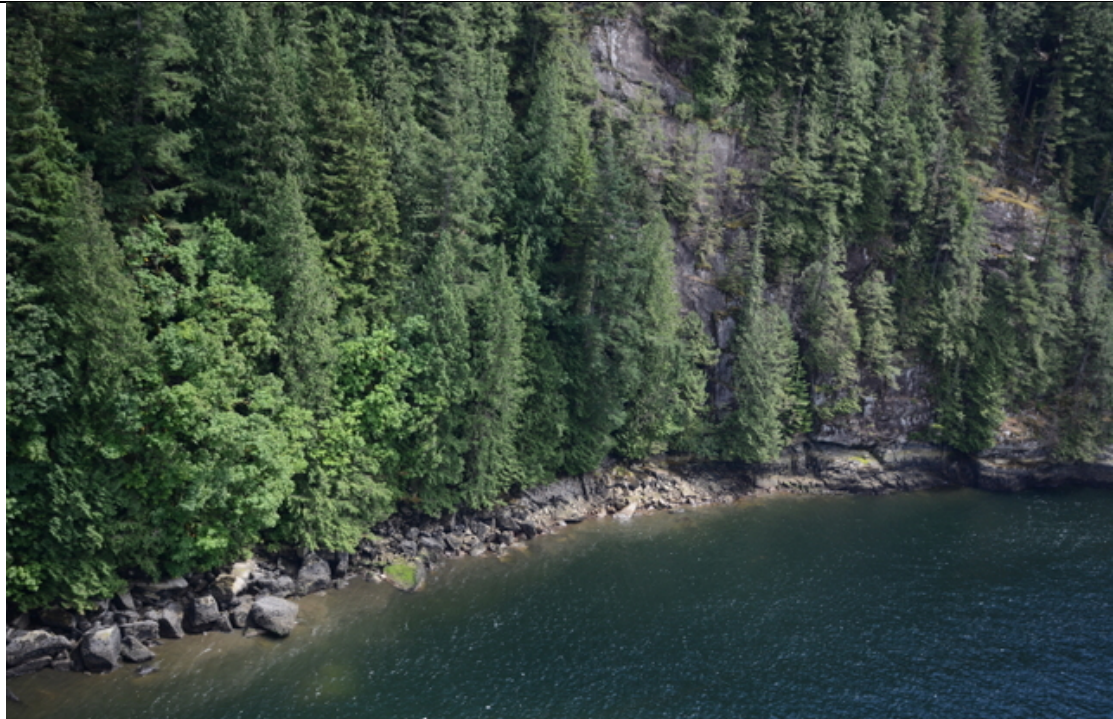
Photo bc17_br_02287: Example of Coastal Class 8; Cliff with gravel beach.
Croker Island, Indian Arm.

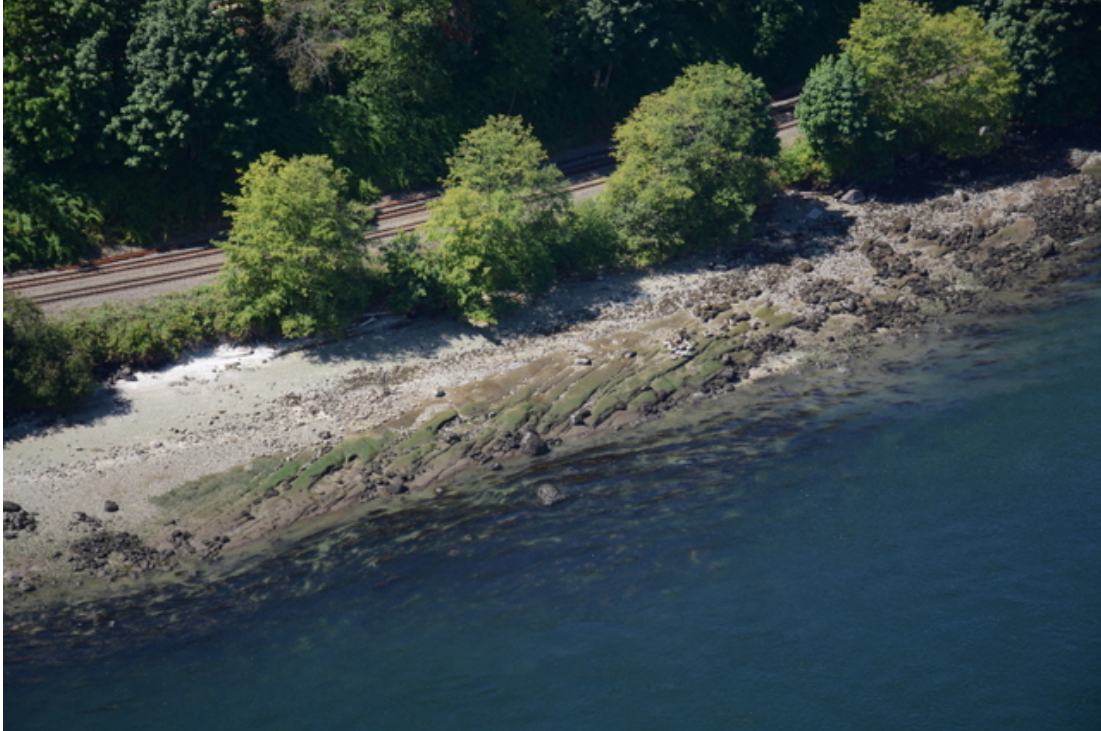
Photo bc17_br_00998: Example of Coastal Class 14; Ramp with gravel and sand beach. Vancouver Harbour.

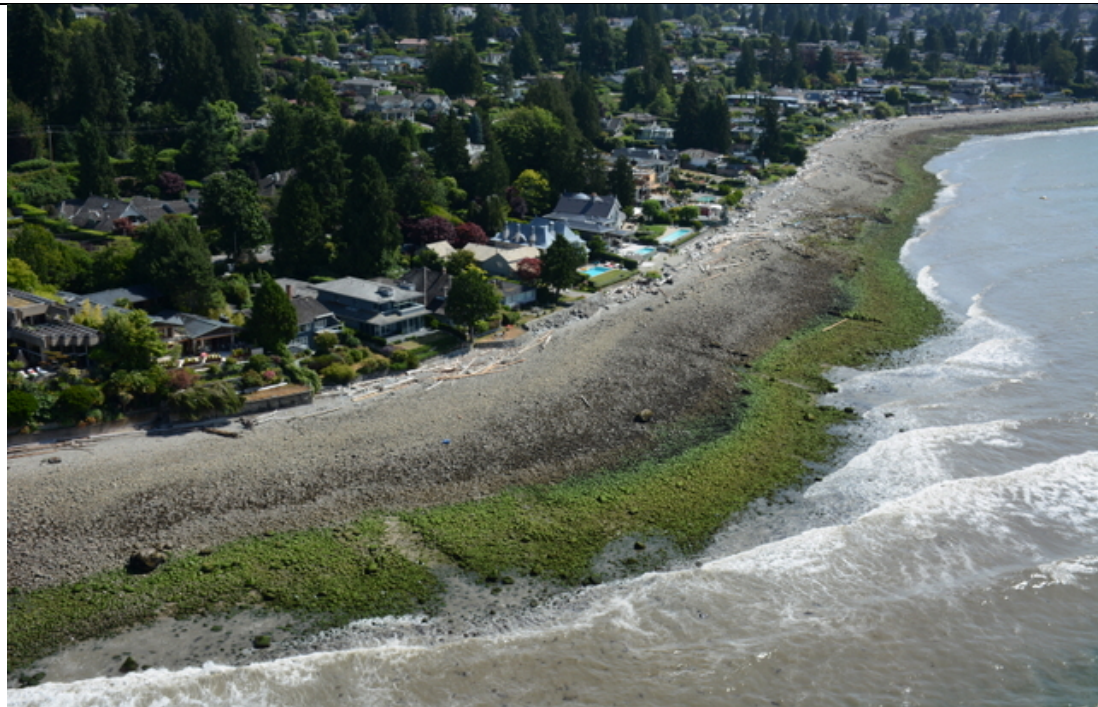
Photo bc17_br_00113: Example of Coastal Class 24; Sand & gravel flat or fan. West Bay, Burrard Inlet.

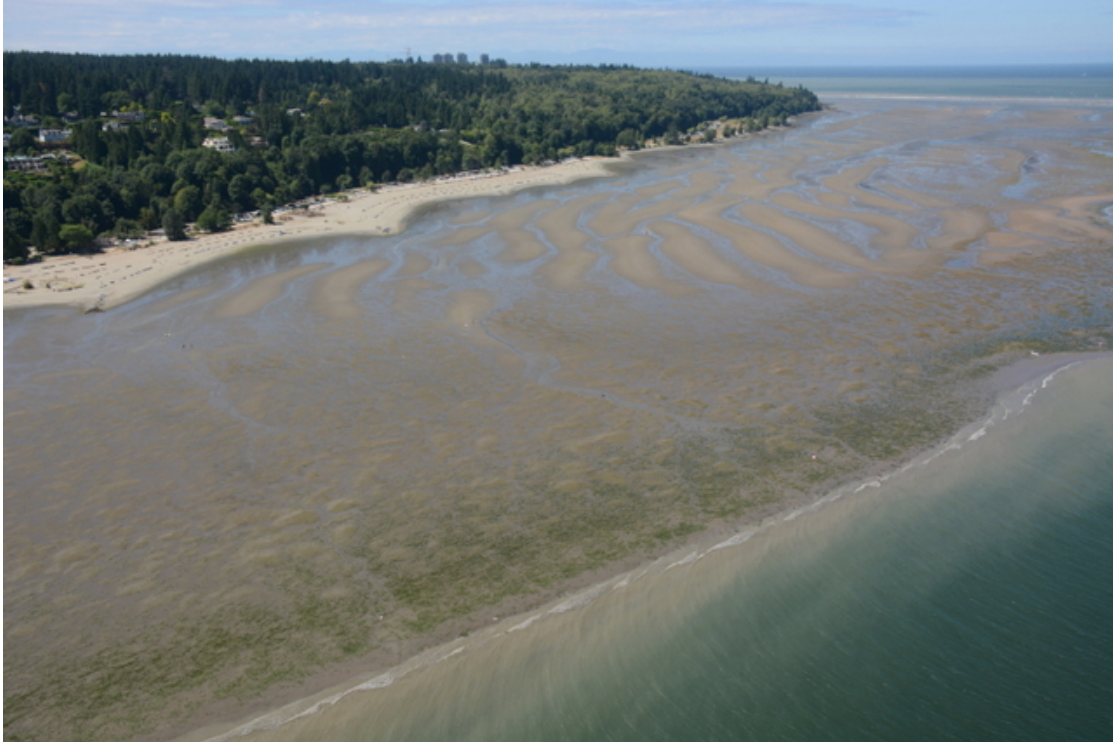
Photo bc17_br_01770: Example of Coastal Class 28; Sand flat. Spanish Banks, Burrard Inlet.

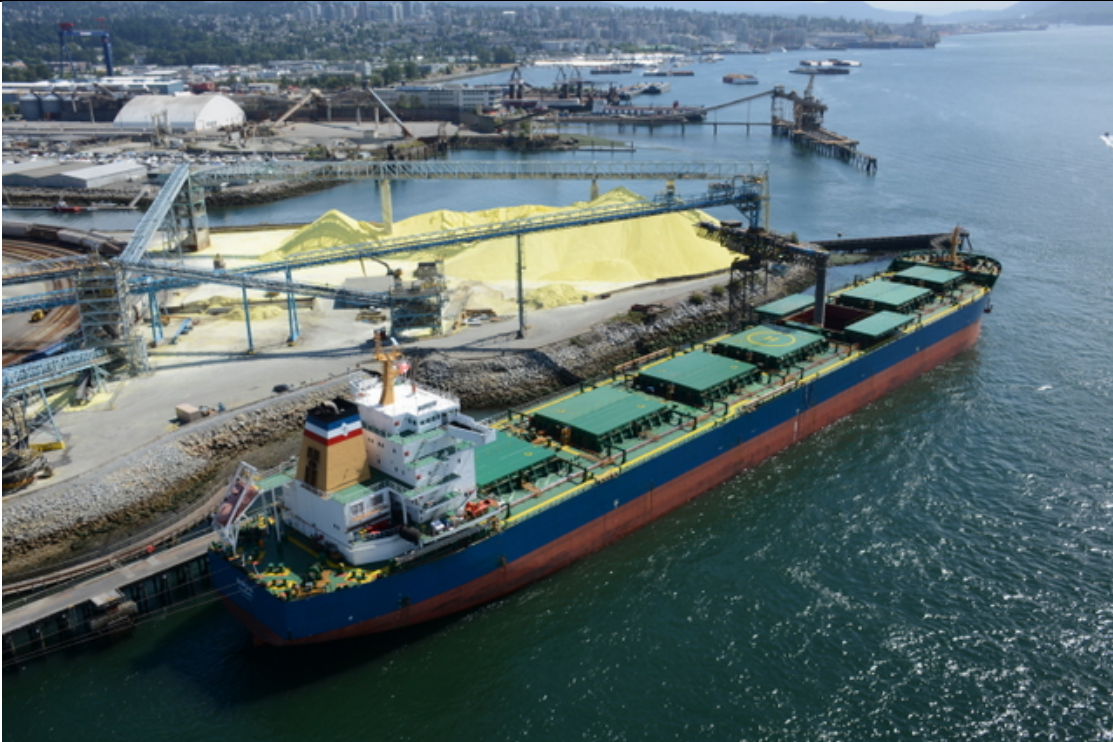
Photo bc17_br_00272: Example of Coastal Class 32; Permeable man-made structures. Vancouver Harbour.

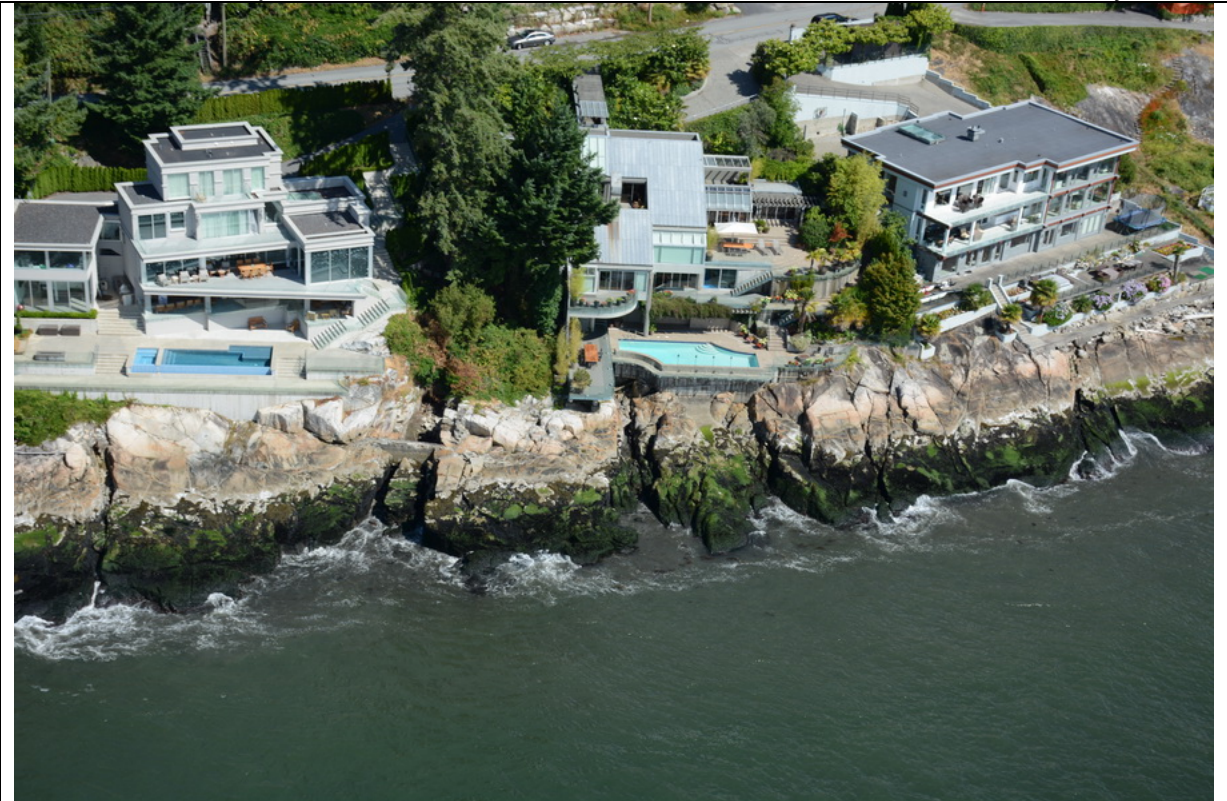
Photo bc17_br_00075: Good example of the Black Lichen (BLLI) bioband which is a black band in the supratidal zone, usually caused by the lichen *Verrucaria* sp. Near Point Atkinson.

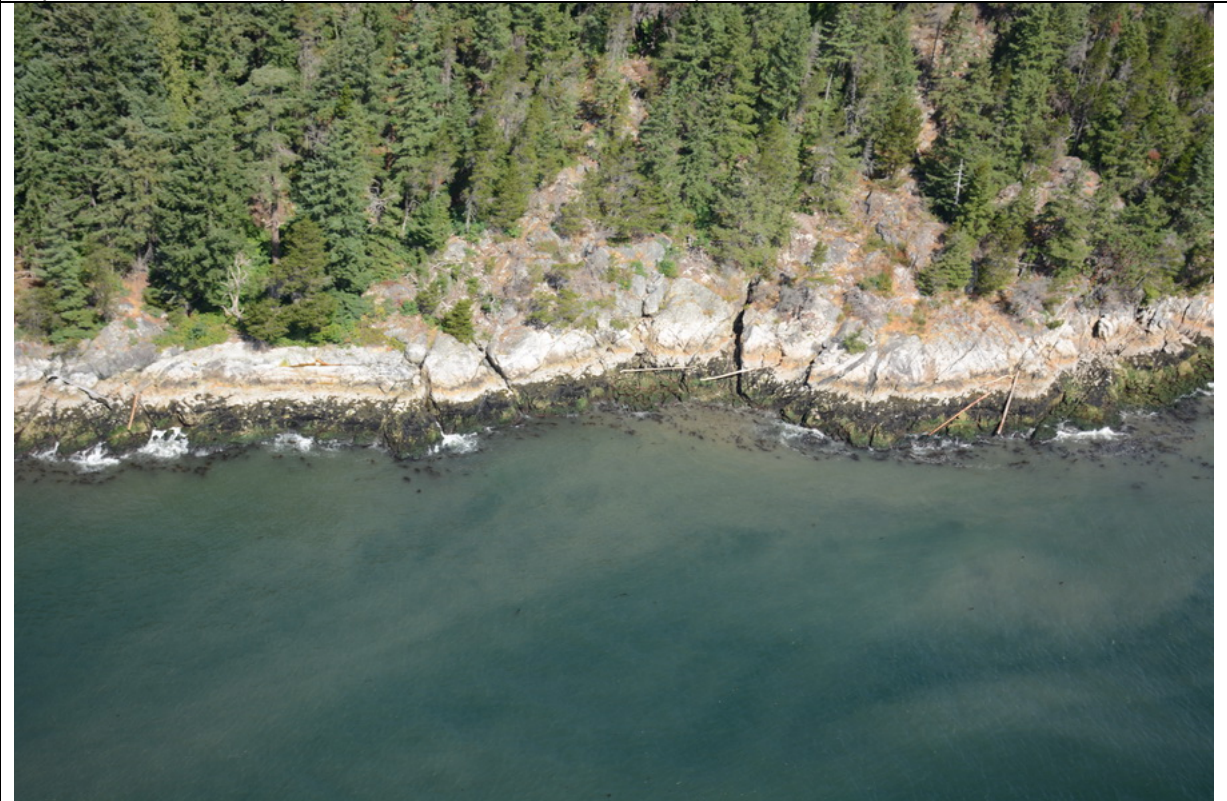
Photo bc17_br_00015: Good example of the Lichen (LICH) bioband which in this case is a pinkish-orange band that occurs with the Black Lichen band. Near Point Atkinson

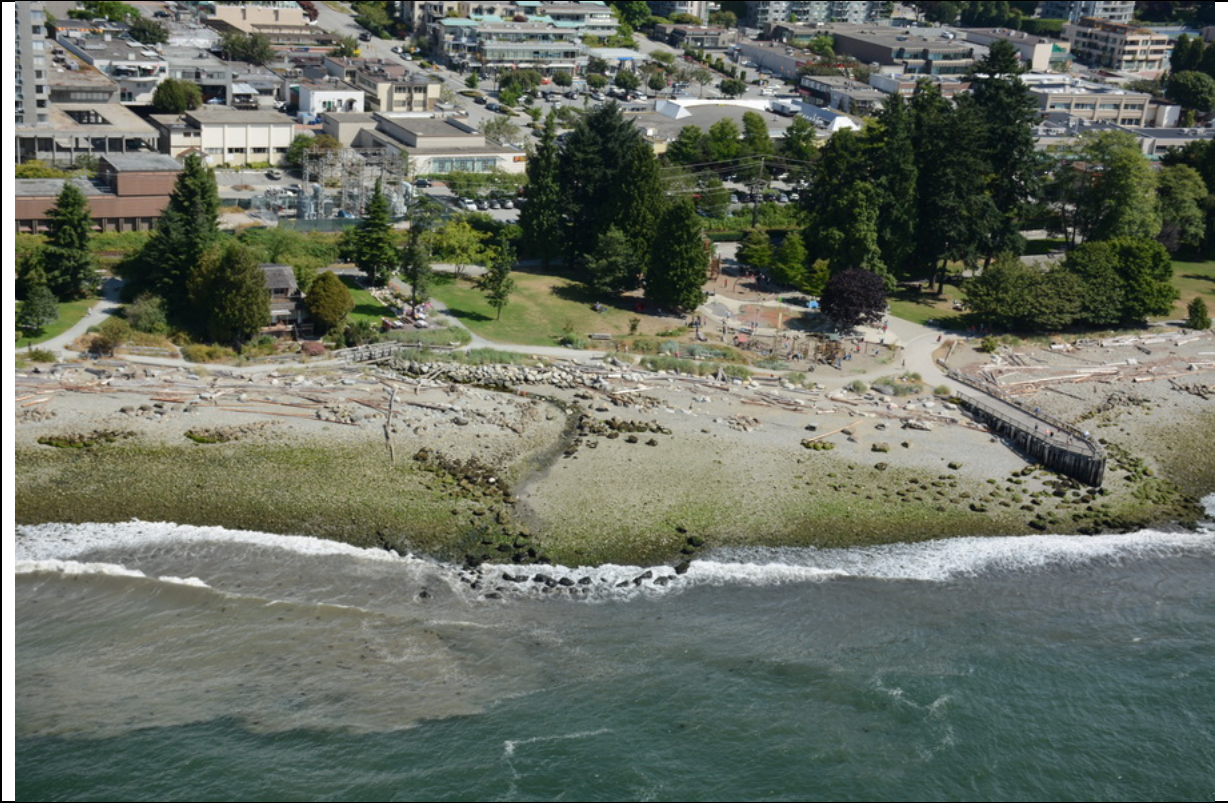
Photo bc17_br_00166: Good example of the Dune Grass (DUGR) bioband as a narrow blue-green strip at the top of the beach.

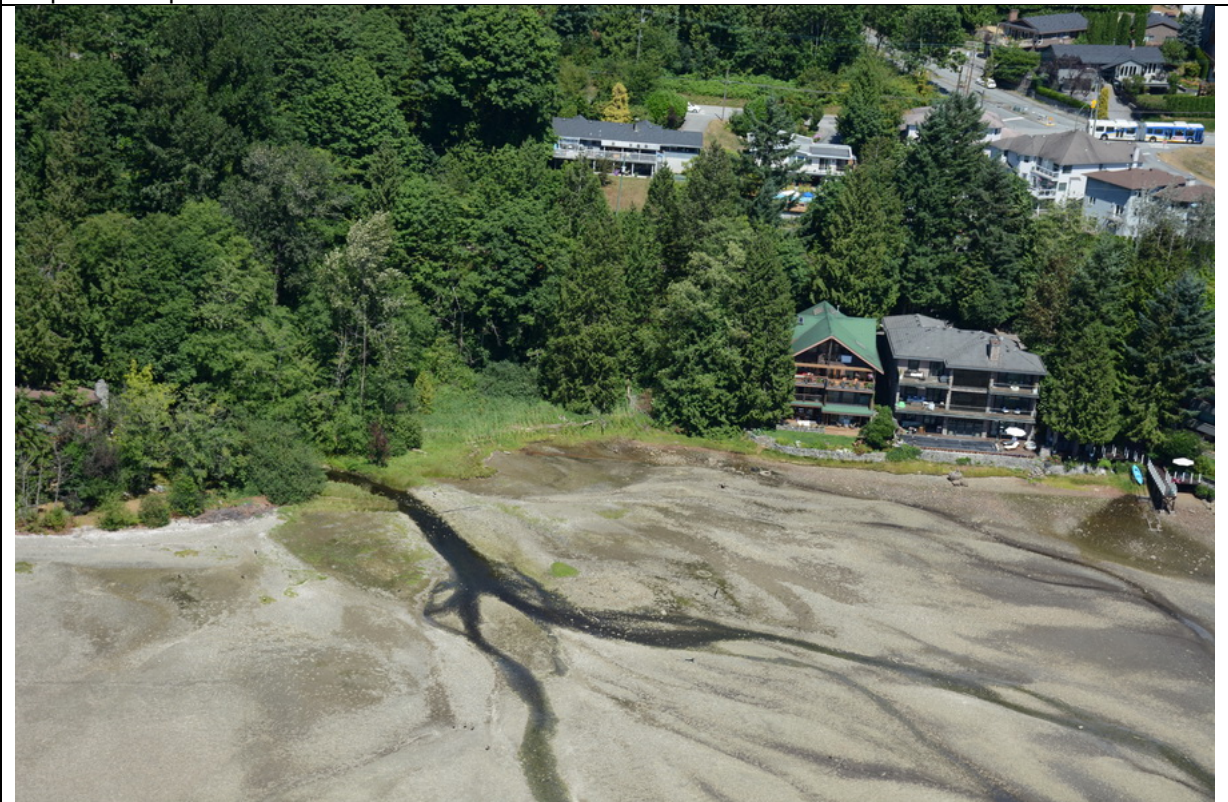
Photo bc17_br_03195: Good example of the Salt Marsh (SAMB) bioband which appears as a light green strip at the top of the beach and extending onto the flats by the delta. This photo also shows Dune Grass above the Salt Marsh. Port Moody.
