ShoreZone Summary Report

Burrard Inlet

ShoreZone Habitat Mapping Summary Report

Burrard Inlet Survey Area

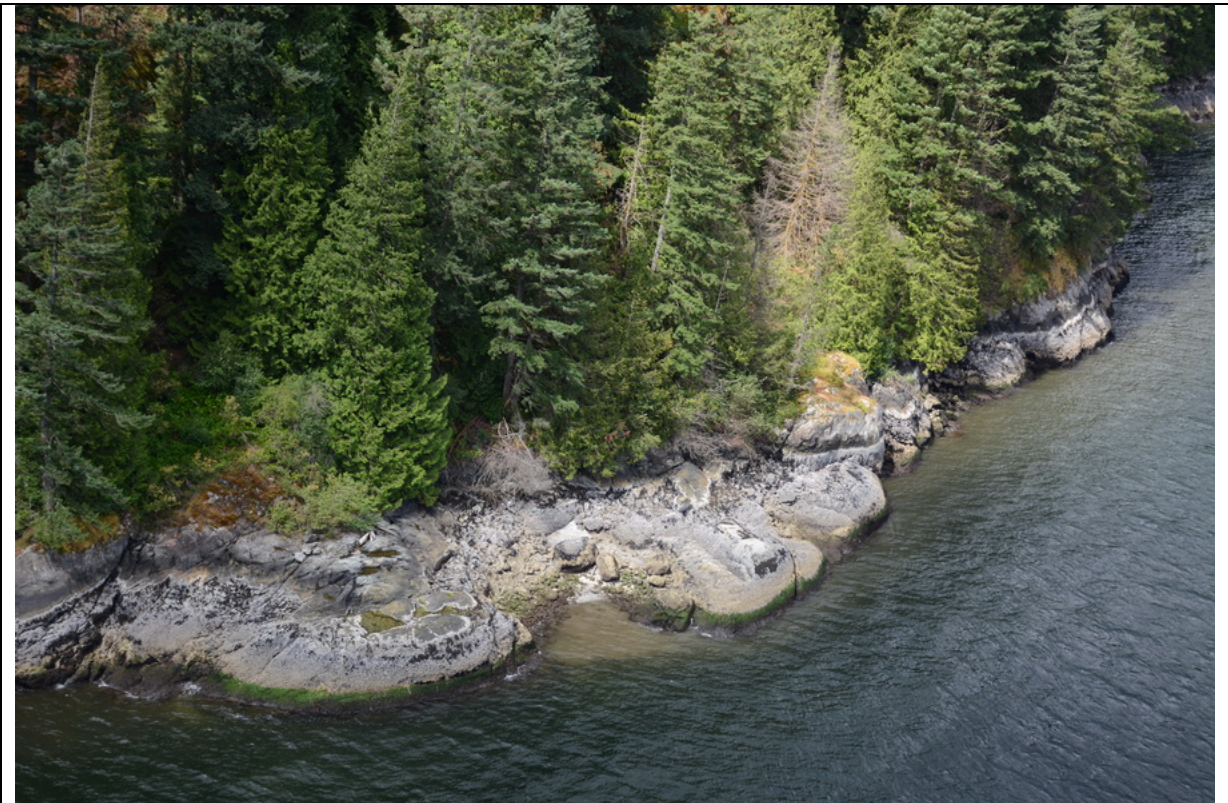
Photo bc17_br_02153: Good example of the Barnacle (BARN) bioband in the high intertidal. It appears white and beige in the survey area Indian Arm.

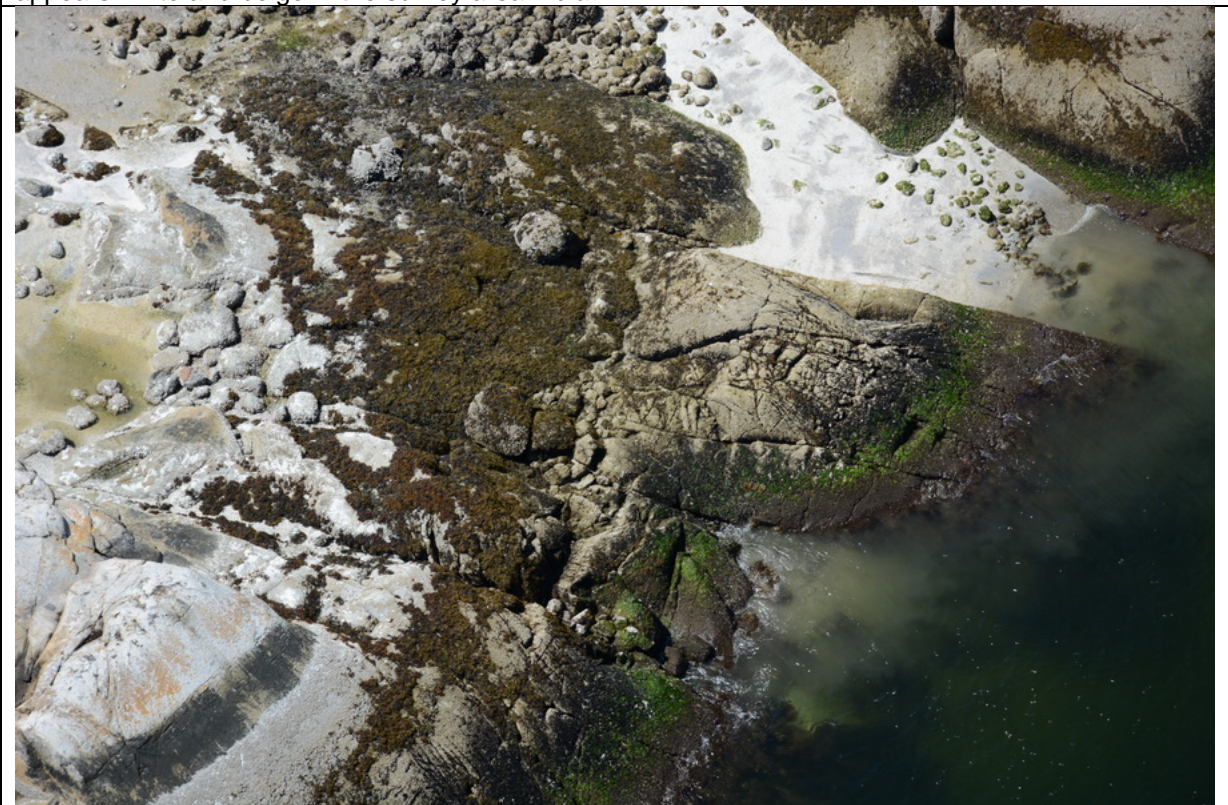
Photo bc17_br_01946: Good example of the Rockweed (ROCK) bioband in the upper intertidal. Indian Arm near Deep Cove.

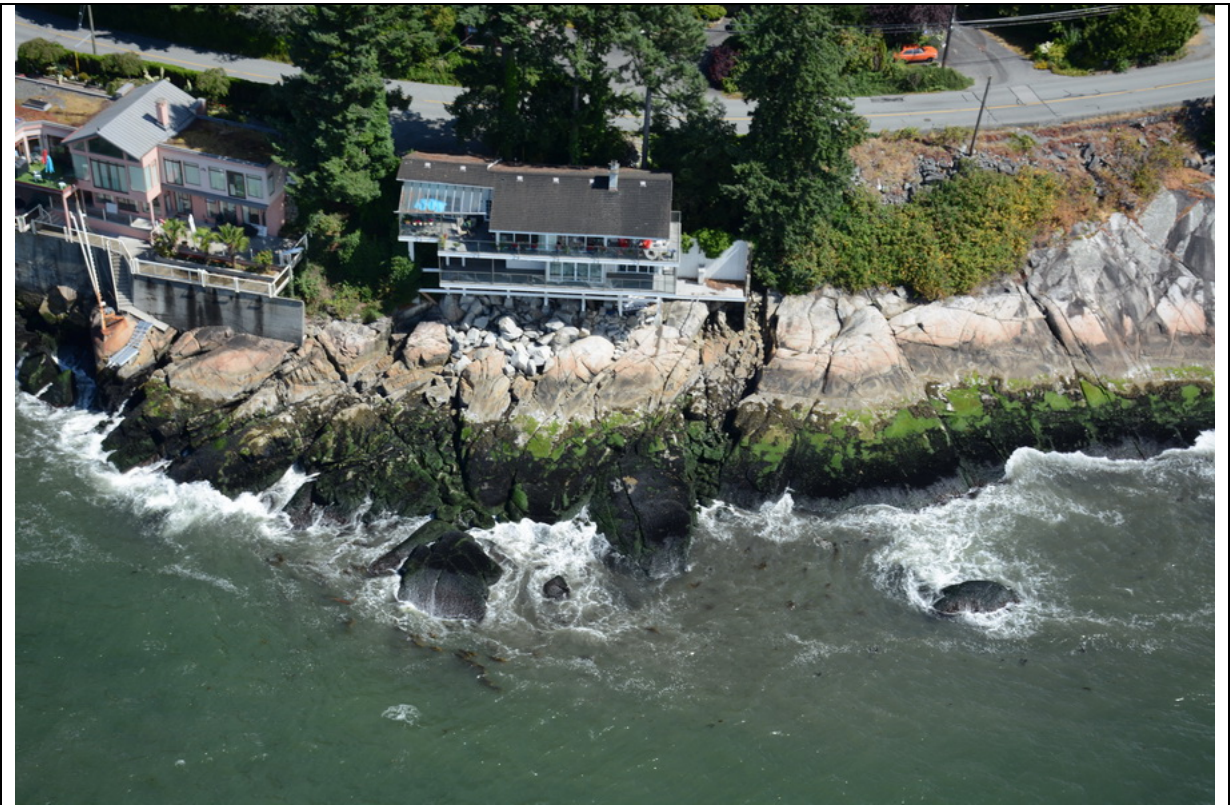
Photo bc17_br_00068: Good example of the black, velvety Blue Mussel (BLMU) bioband in the mid- to lower intertidal. Burrard Inlet.

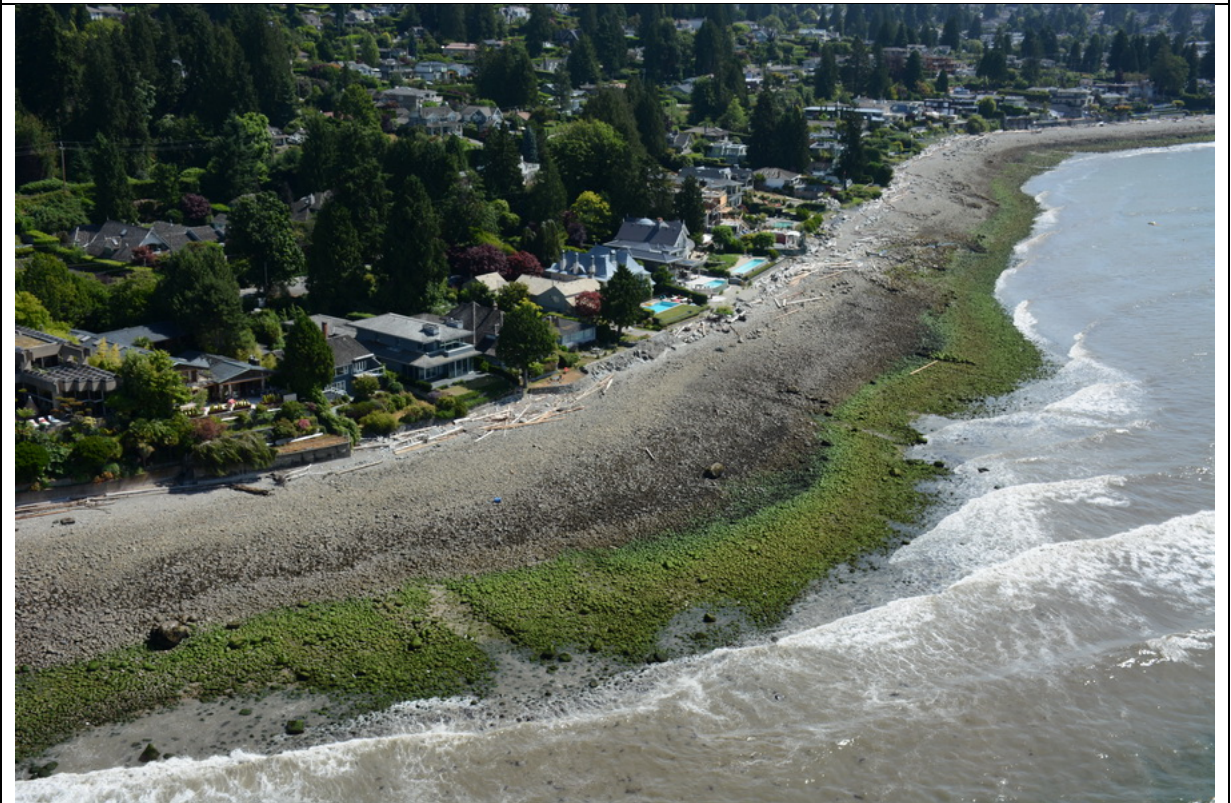
Photo bc17_br_00113: Good example of the Green Algae (GRAL) bioband in the mid- to lower intertidal. Burrard Inlet.

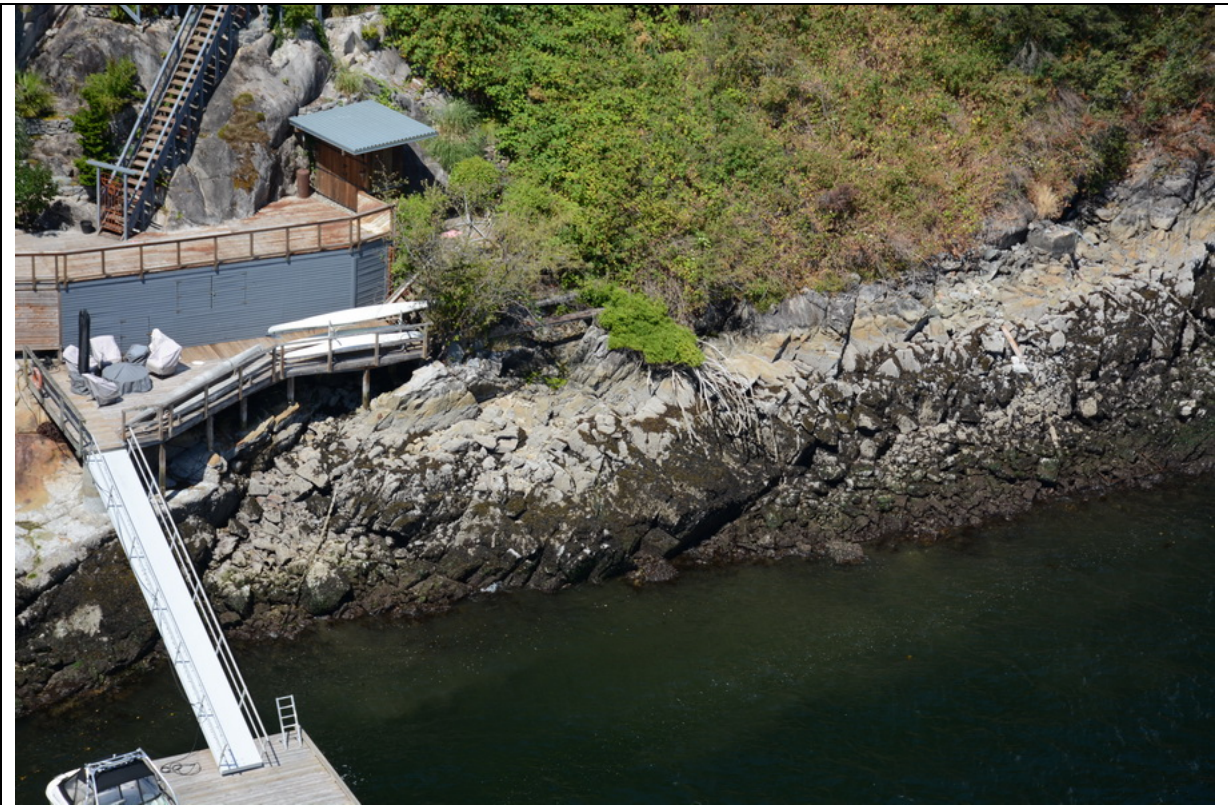
Photo bc17_br_01978: Example of the Filamentous and Foliose Red Algae (FFRA) bioband in the lower intertidal, mixed with Green Algae and Bladed Brown Algae. Indian Arm.

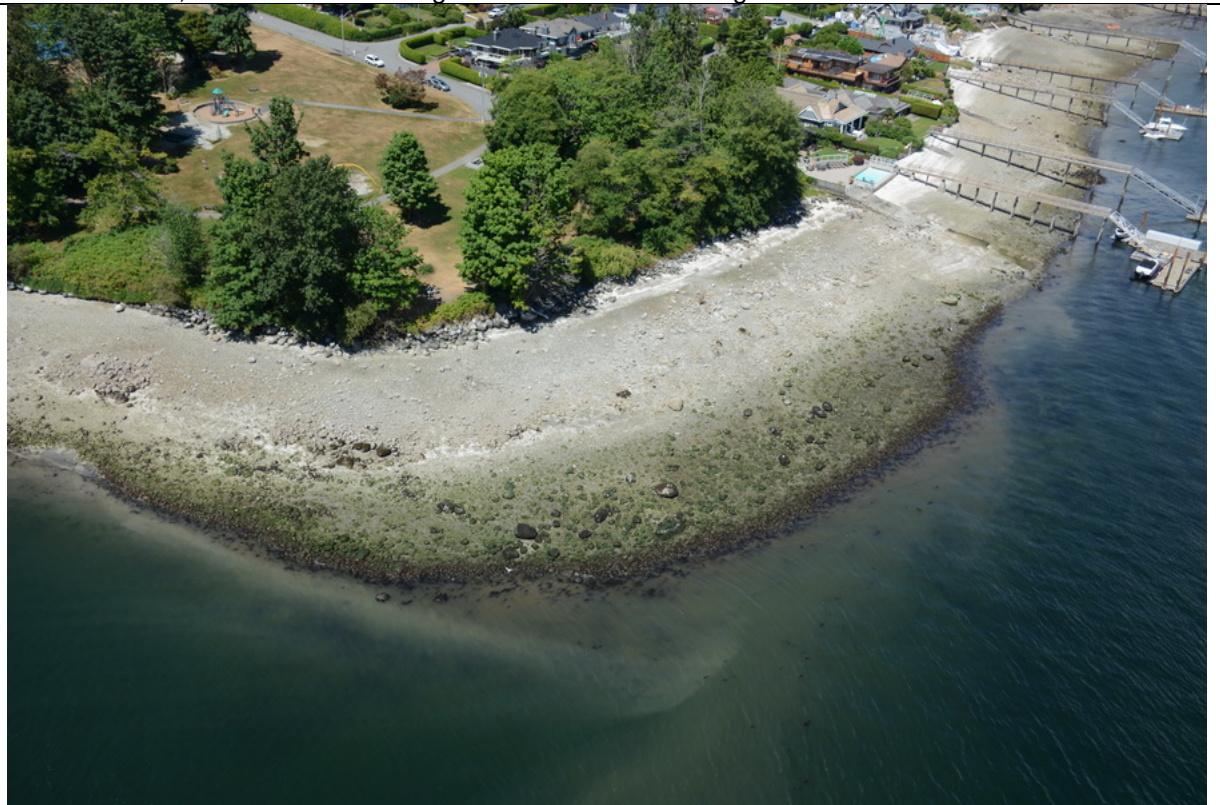
Photo bc17_br_01899: Good example of the Brown Bladed Algae (BRBA) bioband in the lower intertidal, right at the waterline. Entrance to Indian Arm.

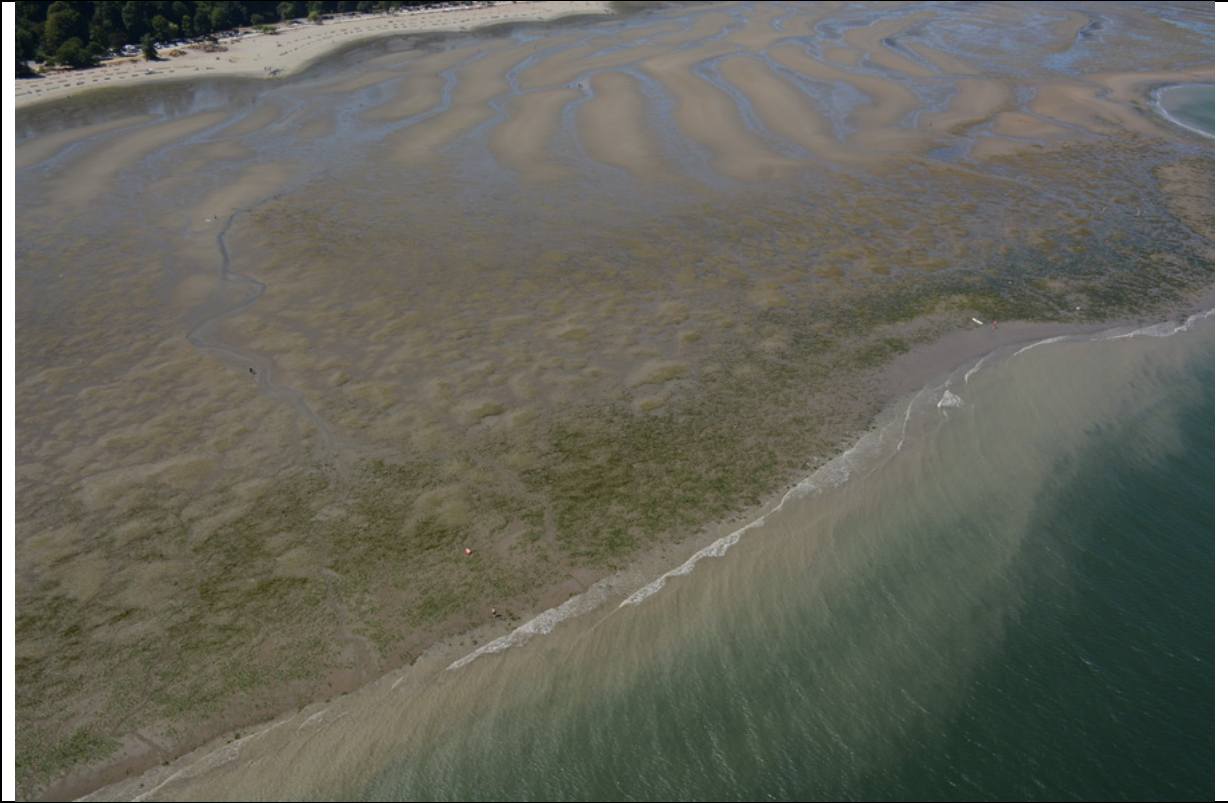
Photo bc17_br_01773: Good example of the Eelgrass (EELG) bioband, mixed with foliose Green Algae, in the lower intertidal. Possibly *Zostera japonica*. Spanish Banks.

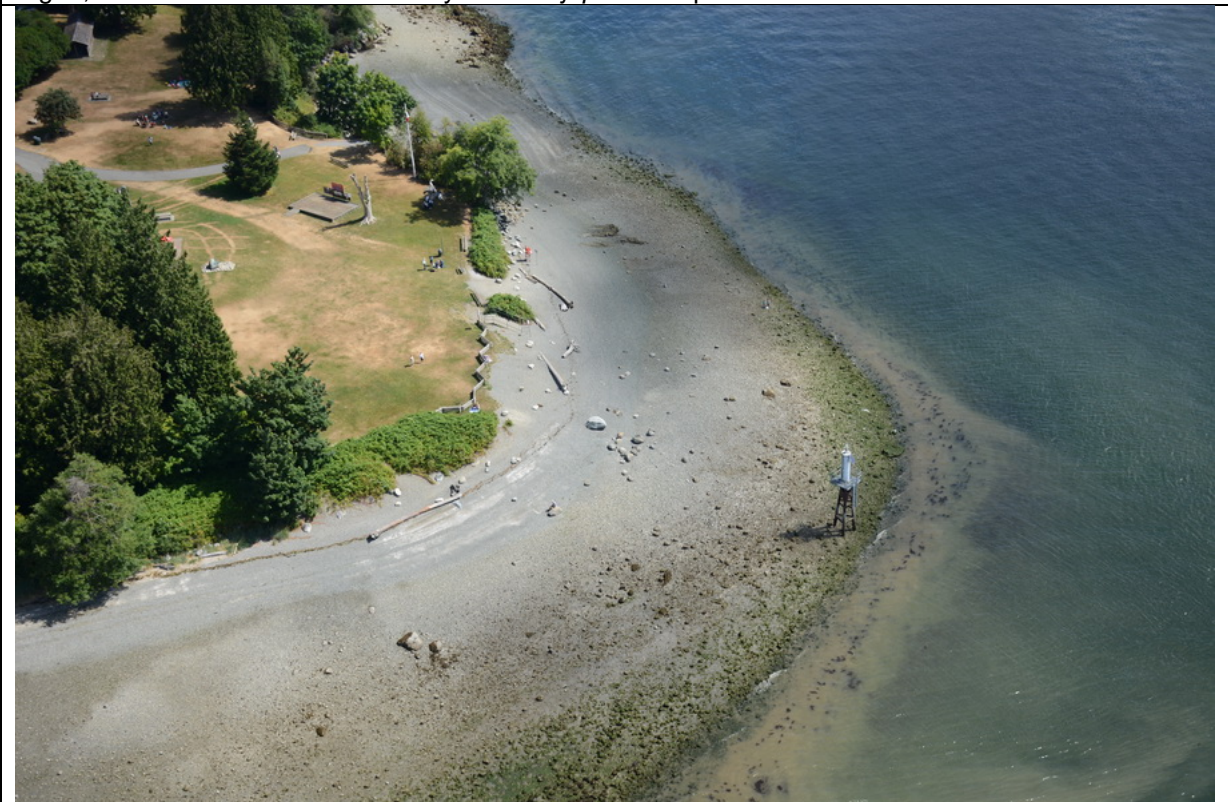
Photo bc17_br_00900: Good example of the Sargassum (SARG) bioband as a narrow strip of brown in the shallow subtidal. This bioband is characterized by a 'fluffy' crown floating on the surface. Entrance to Indian Arm.

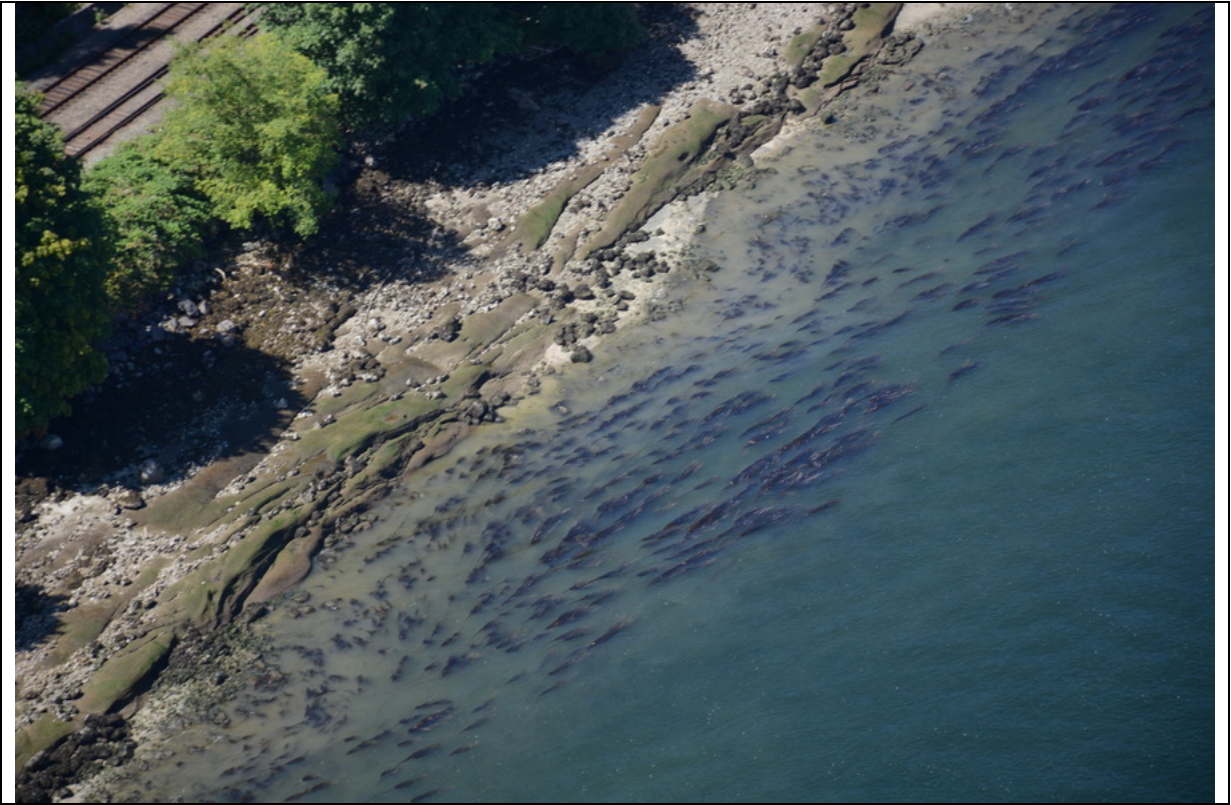
Photo bc17_br_01007: Example of the Bull Kelp (BUKE) bioband in shallow subtidal. Near Iron Workers Memorial Bridge.
